DEPARTMENT OF TRANSPORTATION

Quality Assurance and Source Inspection

Contract #: 04-0120F4Cty: SF/ALA Rte: 80 PM: 13.2/13.9File #: 1.28**WELDING INSPECTION REPORT****Resident Engineer:** Casey, William**Address:** 333 Burma Road**City:** Oakland, CA 94607**Report No:** WIR-028402**Date Inspected:** 14-Sep-2012**Project Name:** SAS Superstructure**OSM Arrival Time:** 700**Prime Contractor:** American Bridge/Fluor Enterprises, a JV**OSM Departure Time:** 1900**Contractor:** American Bridge/Fluor Enterprises, a JV**Location:** jobsite**CWI Name:** Scott Kortum**CWI Present:** Yes No**Inspected CWI report:** Yes No N/A**Rod Oven in Use:** Yes No N/A**Electrode to specification:** Yes No N/A**Weld Procedures Followed:** Yes No N/A**Qualified Welders:** Yes No N/A**Verified Joint Fit-up:** Yes No N/A**Approved Drawings:** Yes No N/A**Approved WPS:** Yes No N/A**Delayed / Cancelled:** Yes No N/A**Bridge No:** 34-0006**Component:** OBG**Summary of Items Observed:**

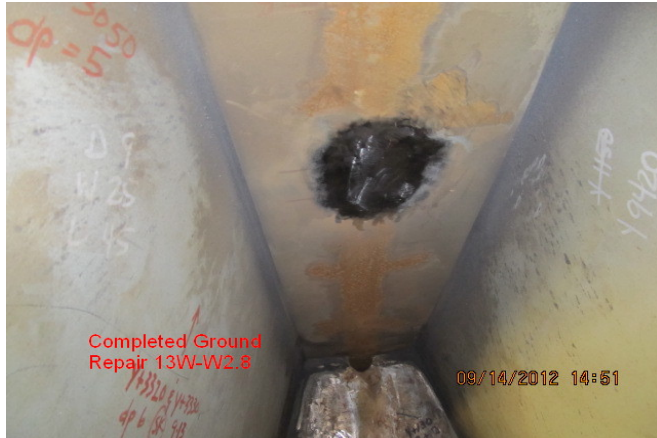
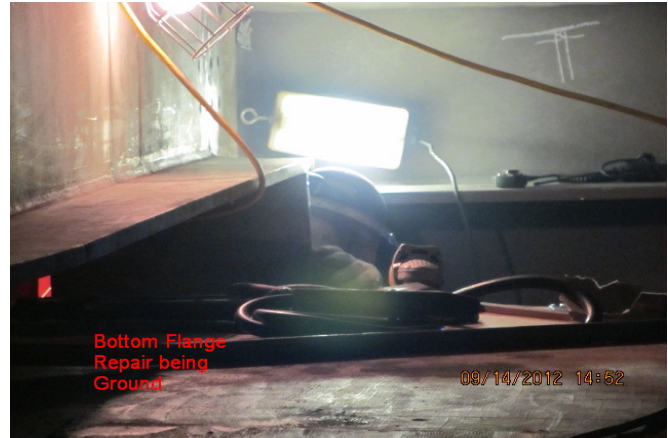
This QA inspector observed weld repair being performed by ABF welding personnel Richard Garcia on Deck Splice 13W-W2.3, at the following location(s):

Y: 2530mm, L: 1500mm, W: 60mm, D: 12mm

This QA Inspector observed Mr. Garcia preheating to a QC recorded, QA verified temperature of 250F prior to using the Carbon Arc Gouging process to remove defects at the above-mentioned locations on the Splice. The locations and depth of the defects had been marked on the steel by the Ultrasonic Technician at the conclusion of his testing. At the end of gouging operations Mr. Garcia ground the excavations to a bright clean metal condition in preparation of Visual, Magnetic Particle Testing, and welding.

The welder spent a fraction of the shift depositing the root passes and fill passes with approximately 50% being completed at the end of the shift. QC inspector Scott Kortum was noted to be present in order to monitor the progress and ensure the welding was within the established Welding Procedure Specification (WPS) noted as ABF-WPS-D15-1004R (Rev 0) and supporting Procedure Qualification Records (PQR). Prior to initiating the welding at this location the QC inspector observed the preheat temperature and post heat temperature using a Raytek non-contact Thermometer, was sufficient and compliant to the above-mentioned WPS. Using a Tempil

Stick, (temperature indicating crayon) the preheat, and post heat temperature was then verified by this QA inspector to be greater than 350F and 450F respectively. Using a Fluke brand Tong style meter, the parameters were verified to be 133 amps
